Tree Assessment

**Deodar Cedar and Norfolk Island Pine
324 Florida
San Bruno, CA**

September 7, 2018

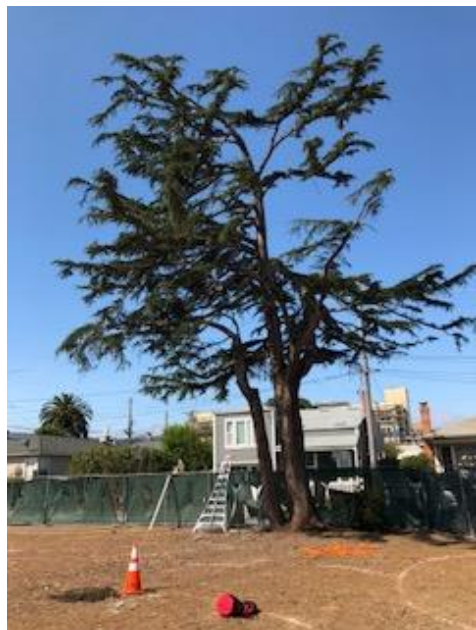
Disfigured Deodara cedar tree near southwestern property line.

The tree in question is a Deodar cedar (*Cedrus deodara*) with diameters at breast height of 29.9 and 15.5 inches. The tree is located in the rear of the property near the southwestern property line. The estimated height of the cedar is 45 feet with a total crown spread of 45 feet. The vigor of the tree is poor-fair with several dead limbs recently being removed. The form of the cedar is poor with multiple leaders at the base and again at 15 feet from a past topping.

The trunk of the tree was covered with ivy and some root crown damage occurred from the removal of the ivy. The abundance of deadwood may be an indicator of crown rot. The cedar was recently trimmed with several of the limbs being shortened. The cedar receives a condition rating of 50 on a 1-100 scale (poor-fair).

Remove and replace the two trees. The Norfolk Island pine will be a constant hazard and will suffer significant root loss. The cedar will always have poor form and will never be an attractive tree. A brand new park should have new safe trees for the neighborhood to enjoy.

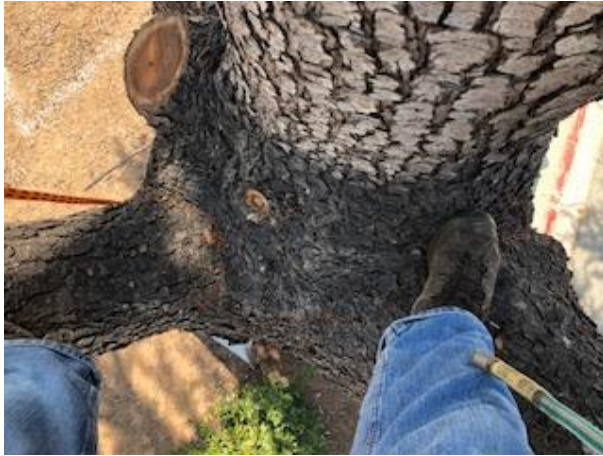
The cedar was climbed to inspect crotch formations and possible decay.

The cedar was climbed to inspect the structure of the tree including the crotch formation at 15 feet and the topping locations. The Norfolk Island pine had several of the large seed pods removed by using a tree climber's throw line. The throw line was able to reach pods at approximately 40 feet.

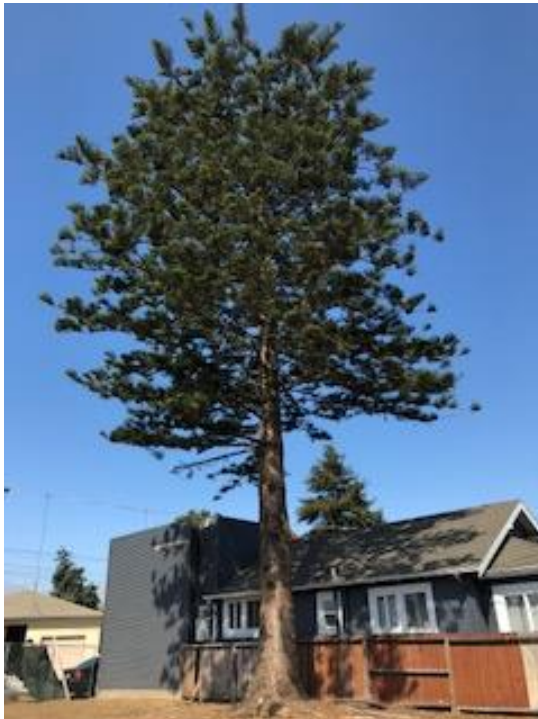
Tree #2 is a Norfolk Island pine (*Araucaria heterophylla*) with a diameter at breast height of 37.4 inches. The tree is located in the rear of the lot 4 feet from the property line and the neighboring home. The vigor of the tree is fair with normal shoot growth for the species. The form of the tree is fair with a single straight trunk and very good limb spacing (common for the species). The tree has very large surface roots (12-14 inch diameter). The location of the tree is poor, near the property line and very close to the neighboring home. Large seed pods are visible throughout the tree.

Norfolk Island pine 4 feet from the property line and neighboring home.

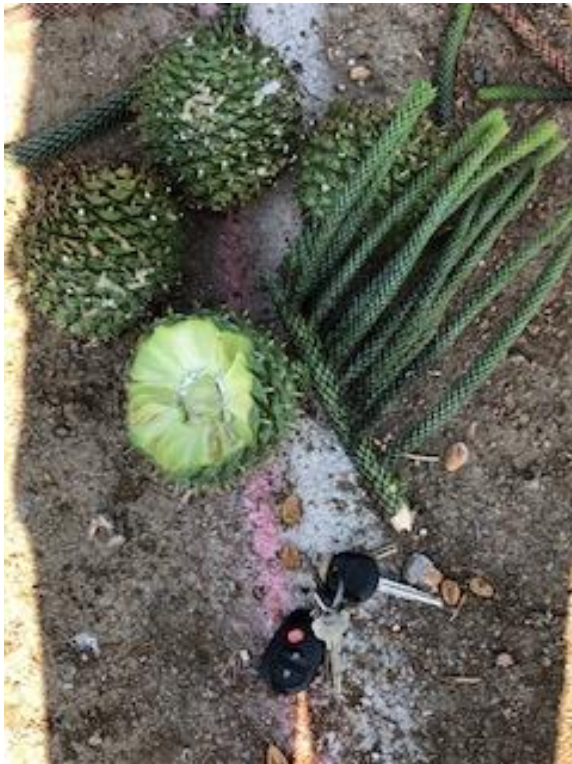
Four large seed pods were pulled from the ends of the limbs of the tree. All four 2-3 pound pods were on the end of the same limb.

The Norfolk Island pine is native to the south pacific. The tree is often used as an indoor plant as the species is sensitive to cold weather. All of the *araucaria* species produce large seed pods that fall without warning. The species is prone to mealy bug a sucking insect that excretes large volumes of honey dew (fecal matter). The honeydew is quite sticky causing damage to vehicles and landscape structures including play equipment.

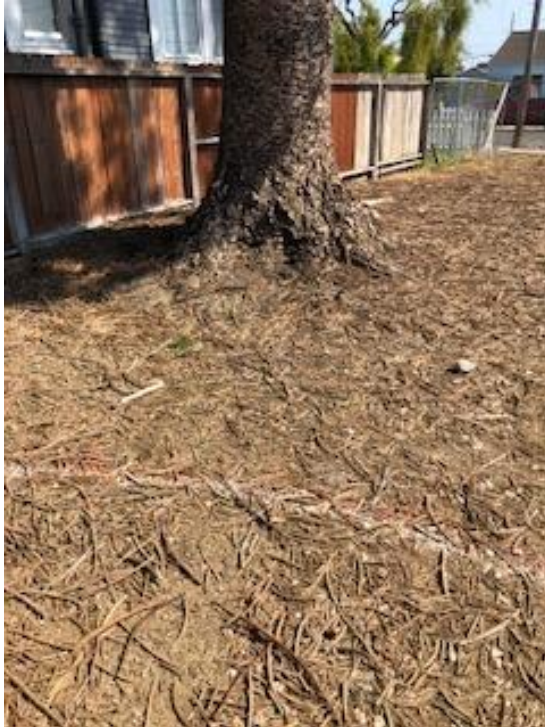
The Norfolk Island pine will be significantly impacted as the pad for the play structure will be within 6 feet of the trunk. The excavation depth for the pad will be approximately 2 feet and will sever the surface oriented roots. Root loss will be between 25-30 percent.

The line in the fore ground is the edge of the playground pad well within the tress dripline and the probable target for falling pods. Excavation will be 2 feet deep and will cause significant root loss.
