SAN BRUNO RECREATION & AQUATIC CENTER

Construction Advisory
Committee Update

March 15, 2023

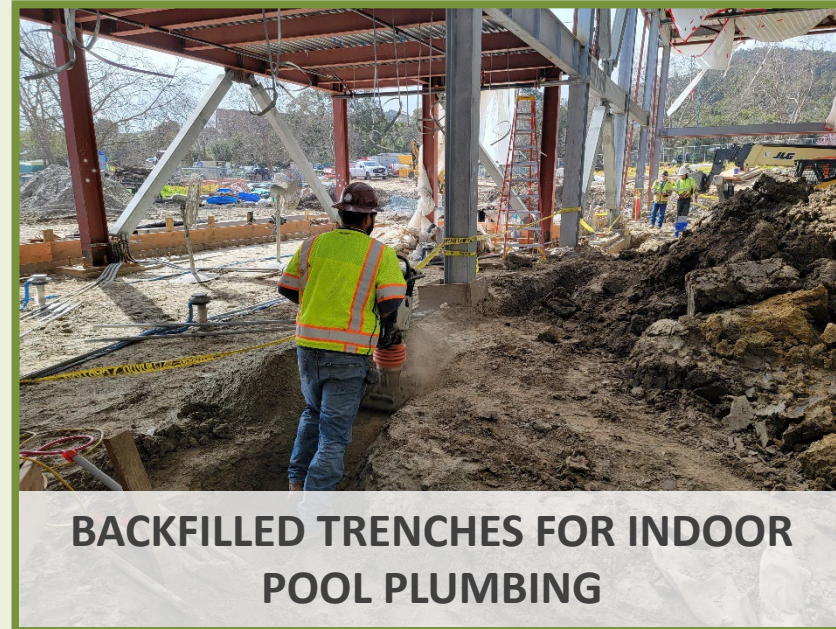
BACKFILLED TRENCHES FOR INDOOR POOL PLUMBING

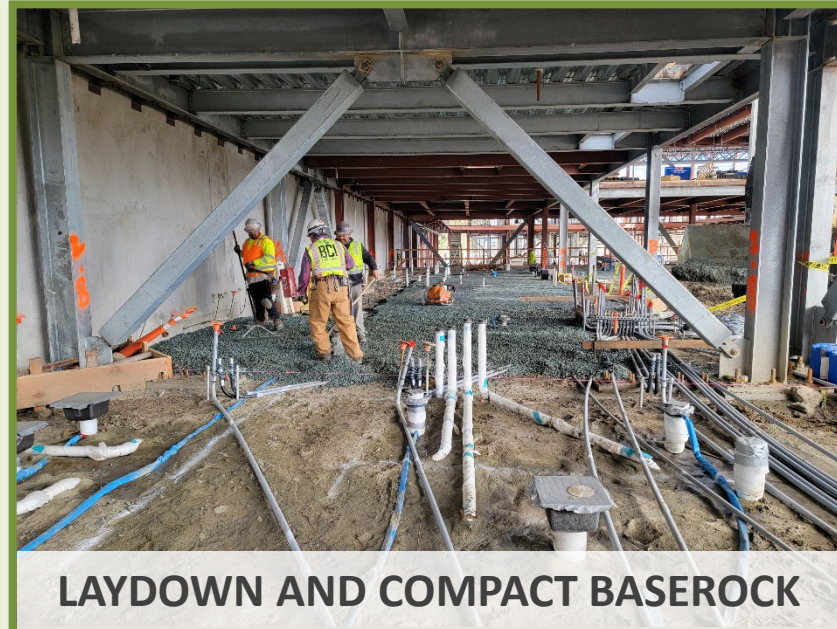
LAYDOWN AND COMPACT BASEROCK

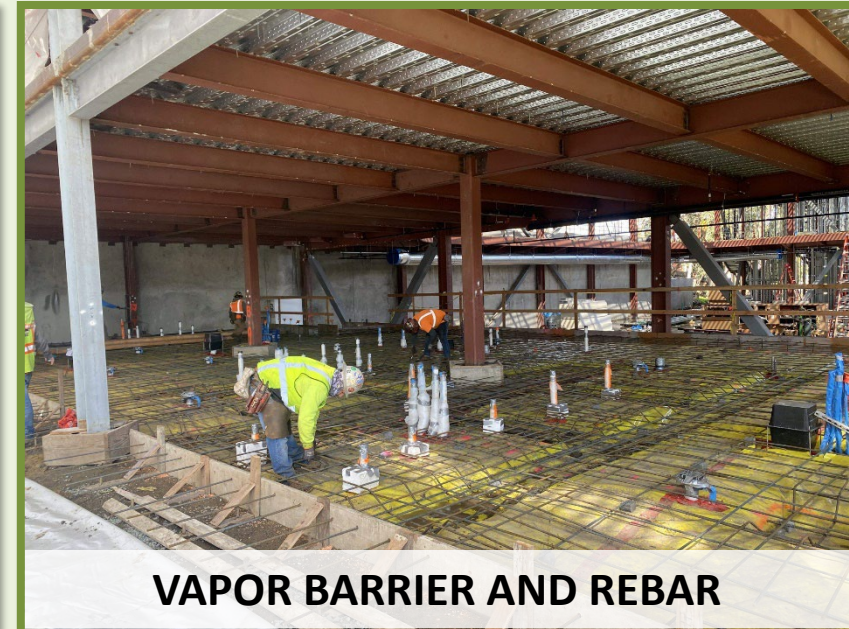
VAPOR BARRIER AND REBAR

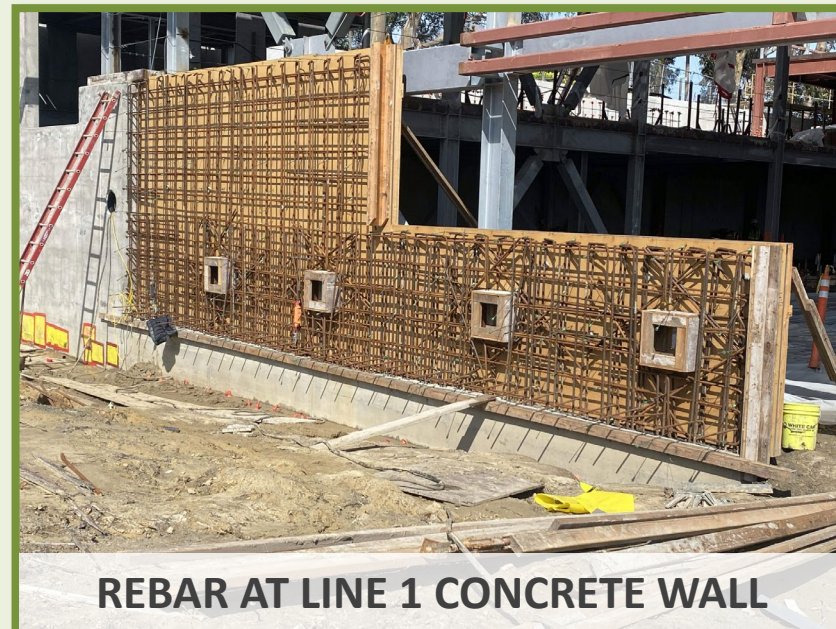
REBAR AT LINE 1 CONCRETE WALL

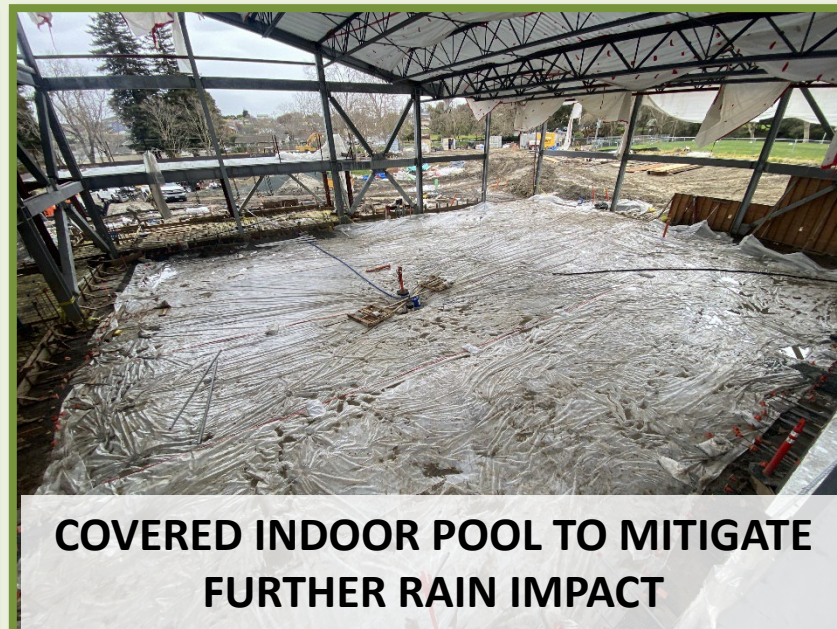
COVERED INDOOR POOL TO MITIGATE FURTHER RAIN IMPACT

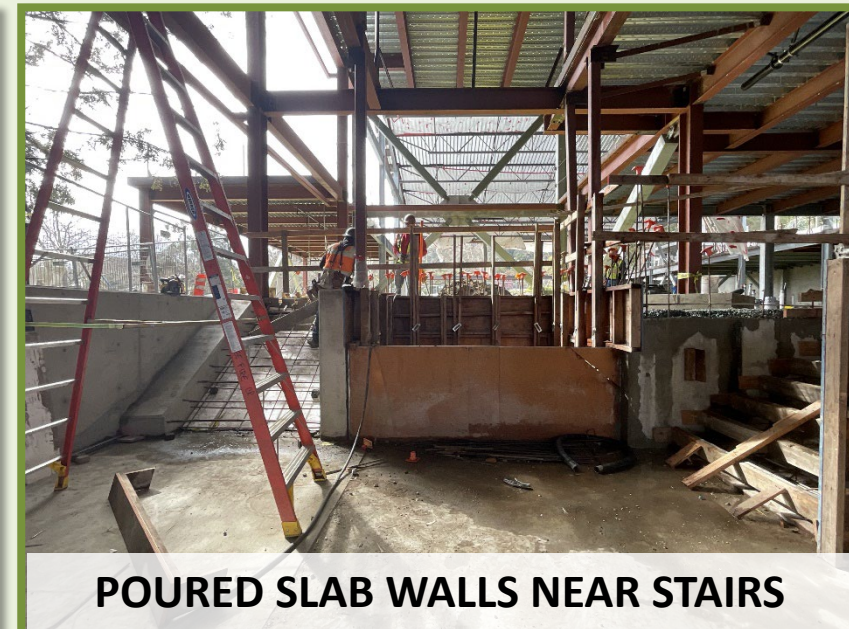
POURED SLAB WALLS NEAR STAIRS

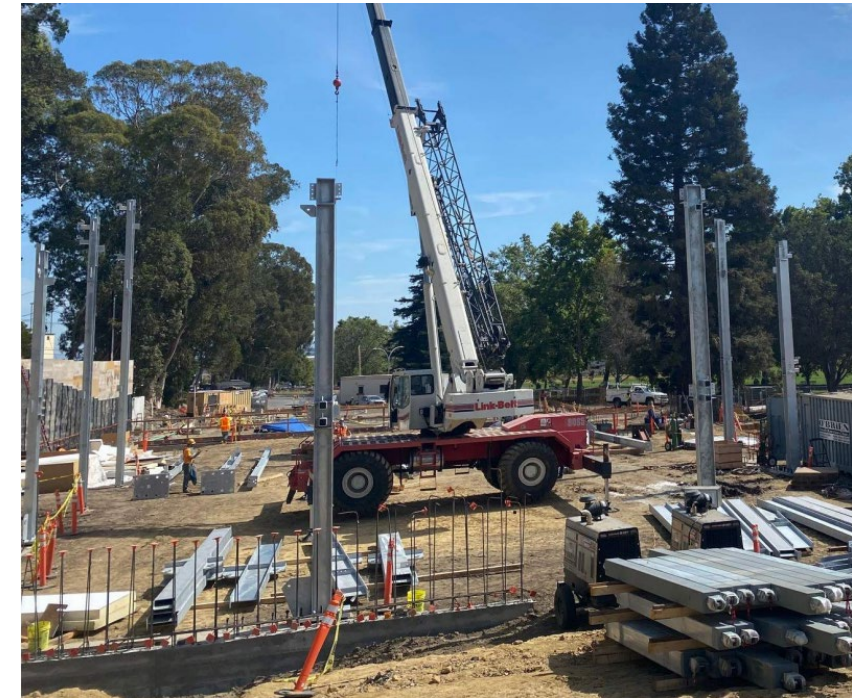
Main Building's Structural Framing System For Code Compliance

STRUCTURAL REVISIONS REQUIRED ADDITIONAL FABRICATION AND STEEL ERECTION COST TO MEET DESIGN REQUIREMENTS AND SCHEDULE.

Compensate the additional labor and equipment cost.

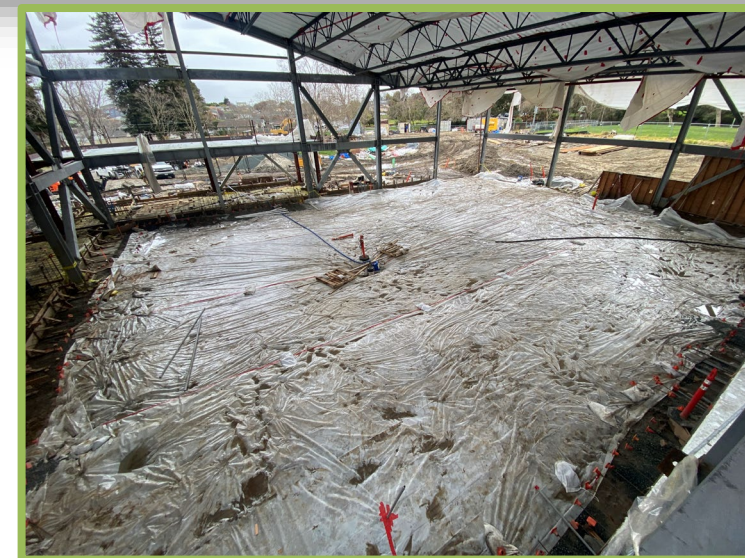
Additional Contaminated Soil Disposal

POOL EXCAVATION - Soil is contaminated with pesticide and petroleum and there is an estimated 3,300 cubic yards of soil remaining to be off-hauled. This soil is from excavation of the indoor pool, outdoor pool, wading pool, parking lot and site grading.

Dispose contaminated soil to special Class II dump site in Tracy, CA.

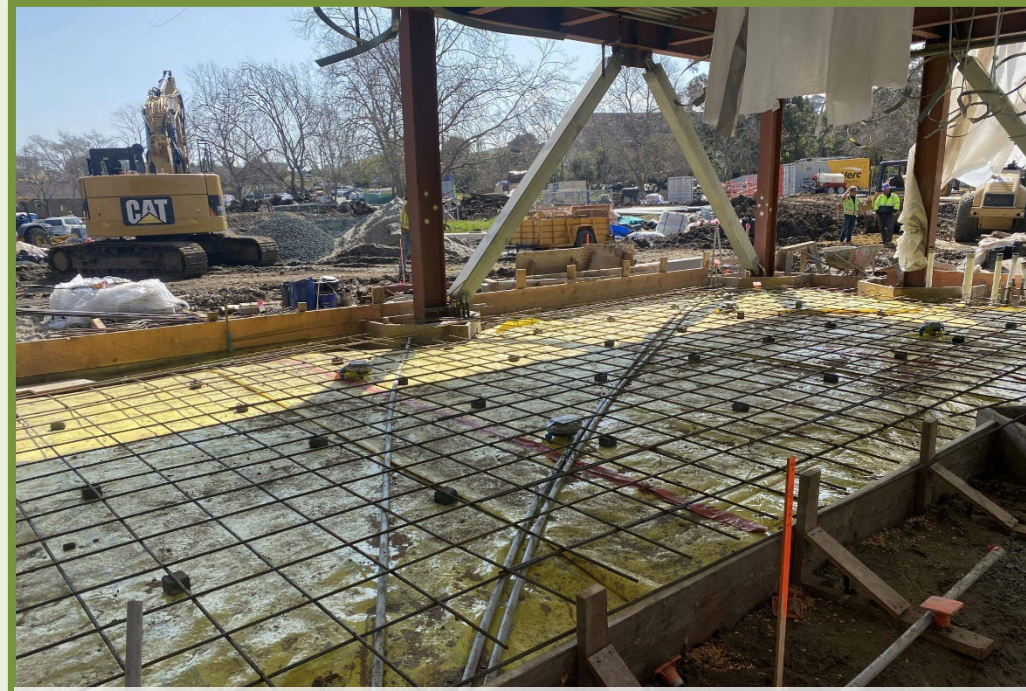
1st FLOOR CONCRETE SLAB AT NATATORIUM

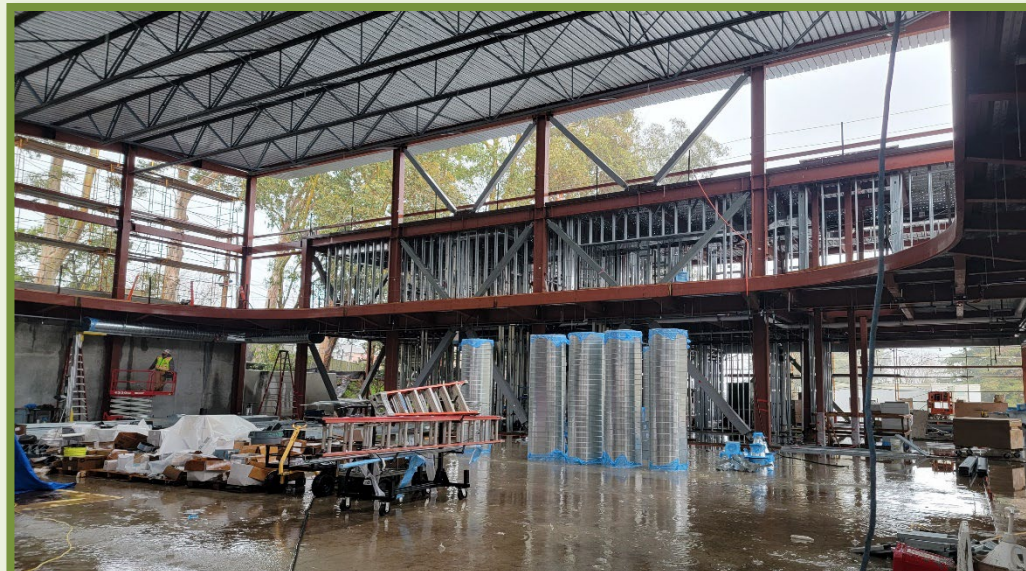
CONTINUE 1st AND 2ND FLOOR MEP

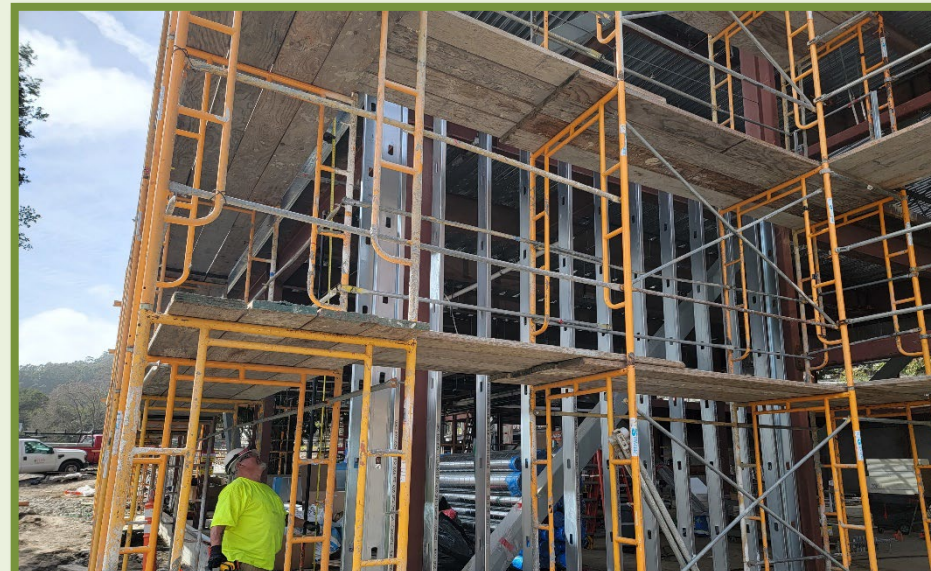
INSTALL EXTERIOR WALLS SHEATHING
